Thermography Report

Customer / Site	
Address	Harristown QLD 4350
Thermography Date	14/04/2024
Thermographer	
Modified Date	14/04/2025

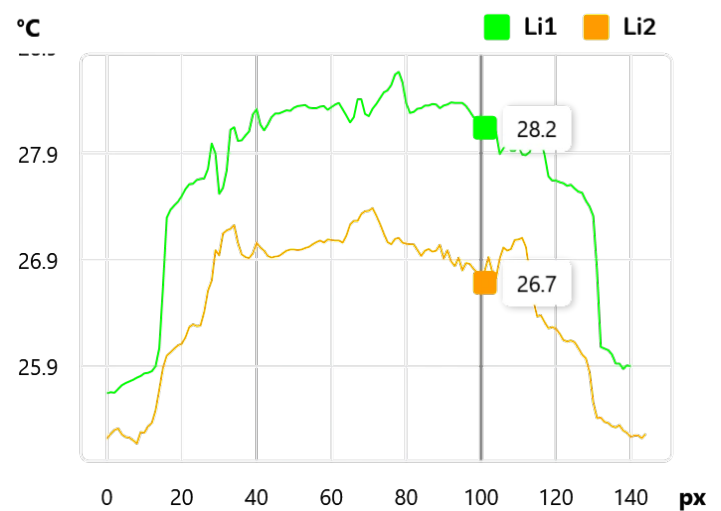
Company	
Barcode	00001839
Location	Main Switchboard
Object ID	10 amp Inverter Right
Fault Description	No fault found
Remedy	Maintain regular thermal Imaging
Fault Rating	Normal
Thermographer	Michael Reiken

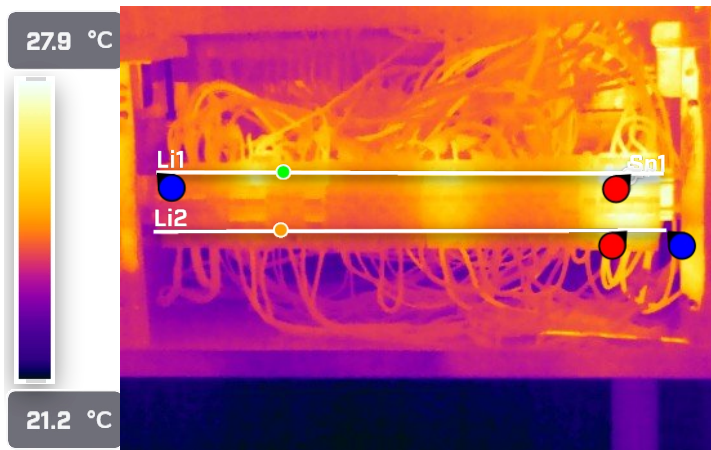
Work Performed	Repaired By:
	Date:

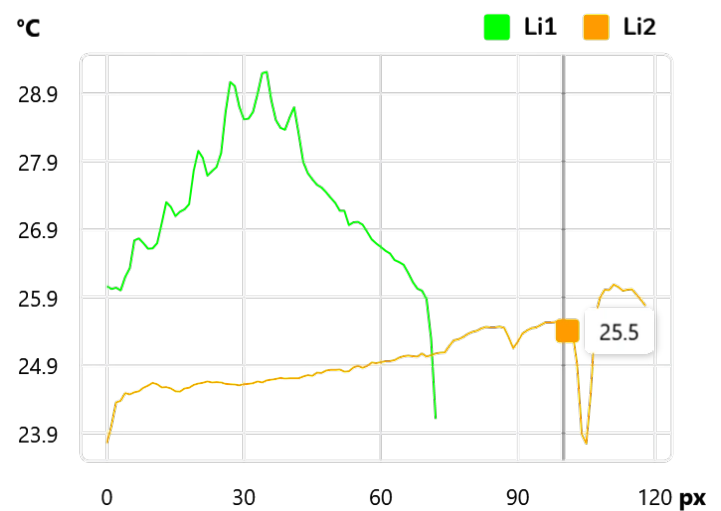
Company	
Barcode	00001838
Location	DB1 front shed
Object ID	Circuit breakers
Fault Description	No fault found
Remedy	Maintain regular thermal imaging
Fault Rating	Normal
Thermographer	Michael Reiken
